Manhole Inspection Summary

Manhole # S33KK1030MH

Insp Date: **2/28/07 10:31 AM**

Location Address: **4216 GREENWAY**

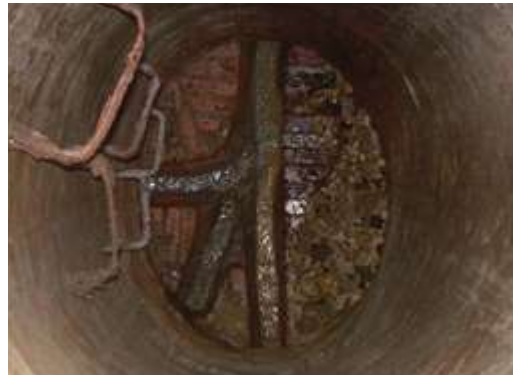
Top View

☐ Parged ☒ **Debris** (not Condition related)

Count: **5** Missing: **0** ☒ **Corroded**

Corroded steps. Bench debris.

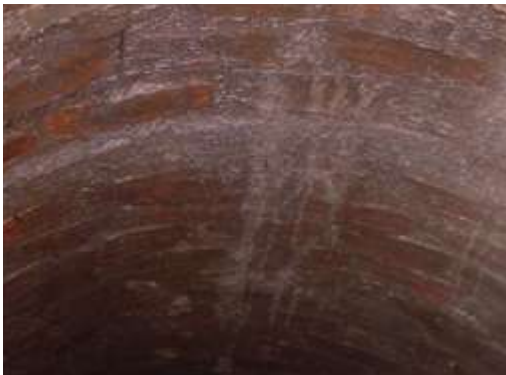
Defect

Infiltration: ☐ None ☒ **Joint** ☐ Cracks ☐ Mortar ☐ Roots ☒ **Wall**

Infiltration: ☐ None ☐ Joint ☐ Cracks ☐ Mortar ☐ Roots ☒ **Wall**

Corbel and Barrel infiltration.

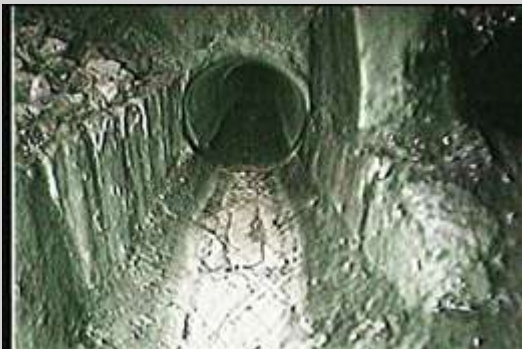
6 in. Circular Gravity Sewer Pipe In @ 6 O'Clock

Condition: ☐ Sound ☒ **Cracked** ☐ Root Intrusion ☒ **Deteriorated** ☐ Leaks ☐ Debris

Channel cracks.

Infiltration: **Evidence** Pipe Seal Cond: **Cracked**

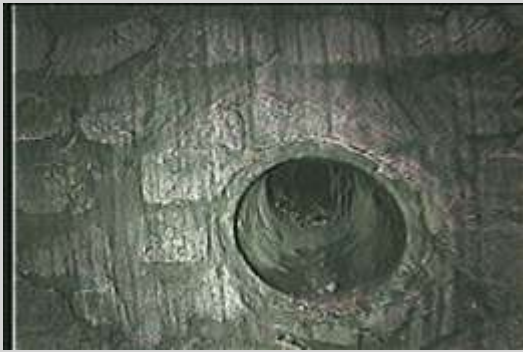
Pipe In @ 7 O'Clock

Infiltration: **Evidence** Pipe Seal Cond: **Unknown**

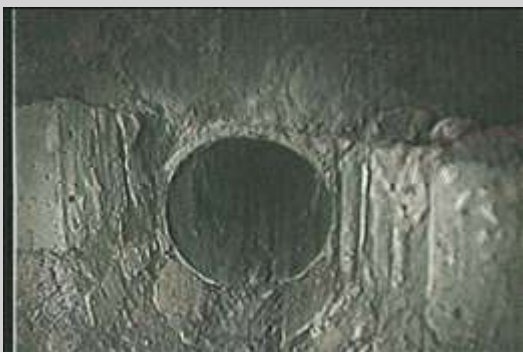
Pipe In @ 9 O'Clock

Channel deterioration.

Infiltration: **Evidence** Pipe Seal Cond: **Roots**
